Report No. CG-WEP-2-79

FATE OF OIL SPILLED FROM THE  
SUPERTANKER METULA

JANUARY 1979

FINAL REPORT

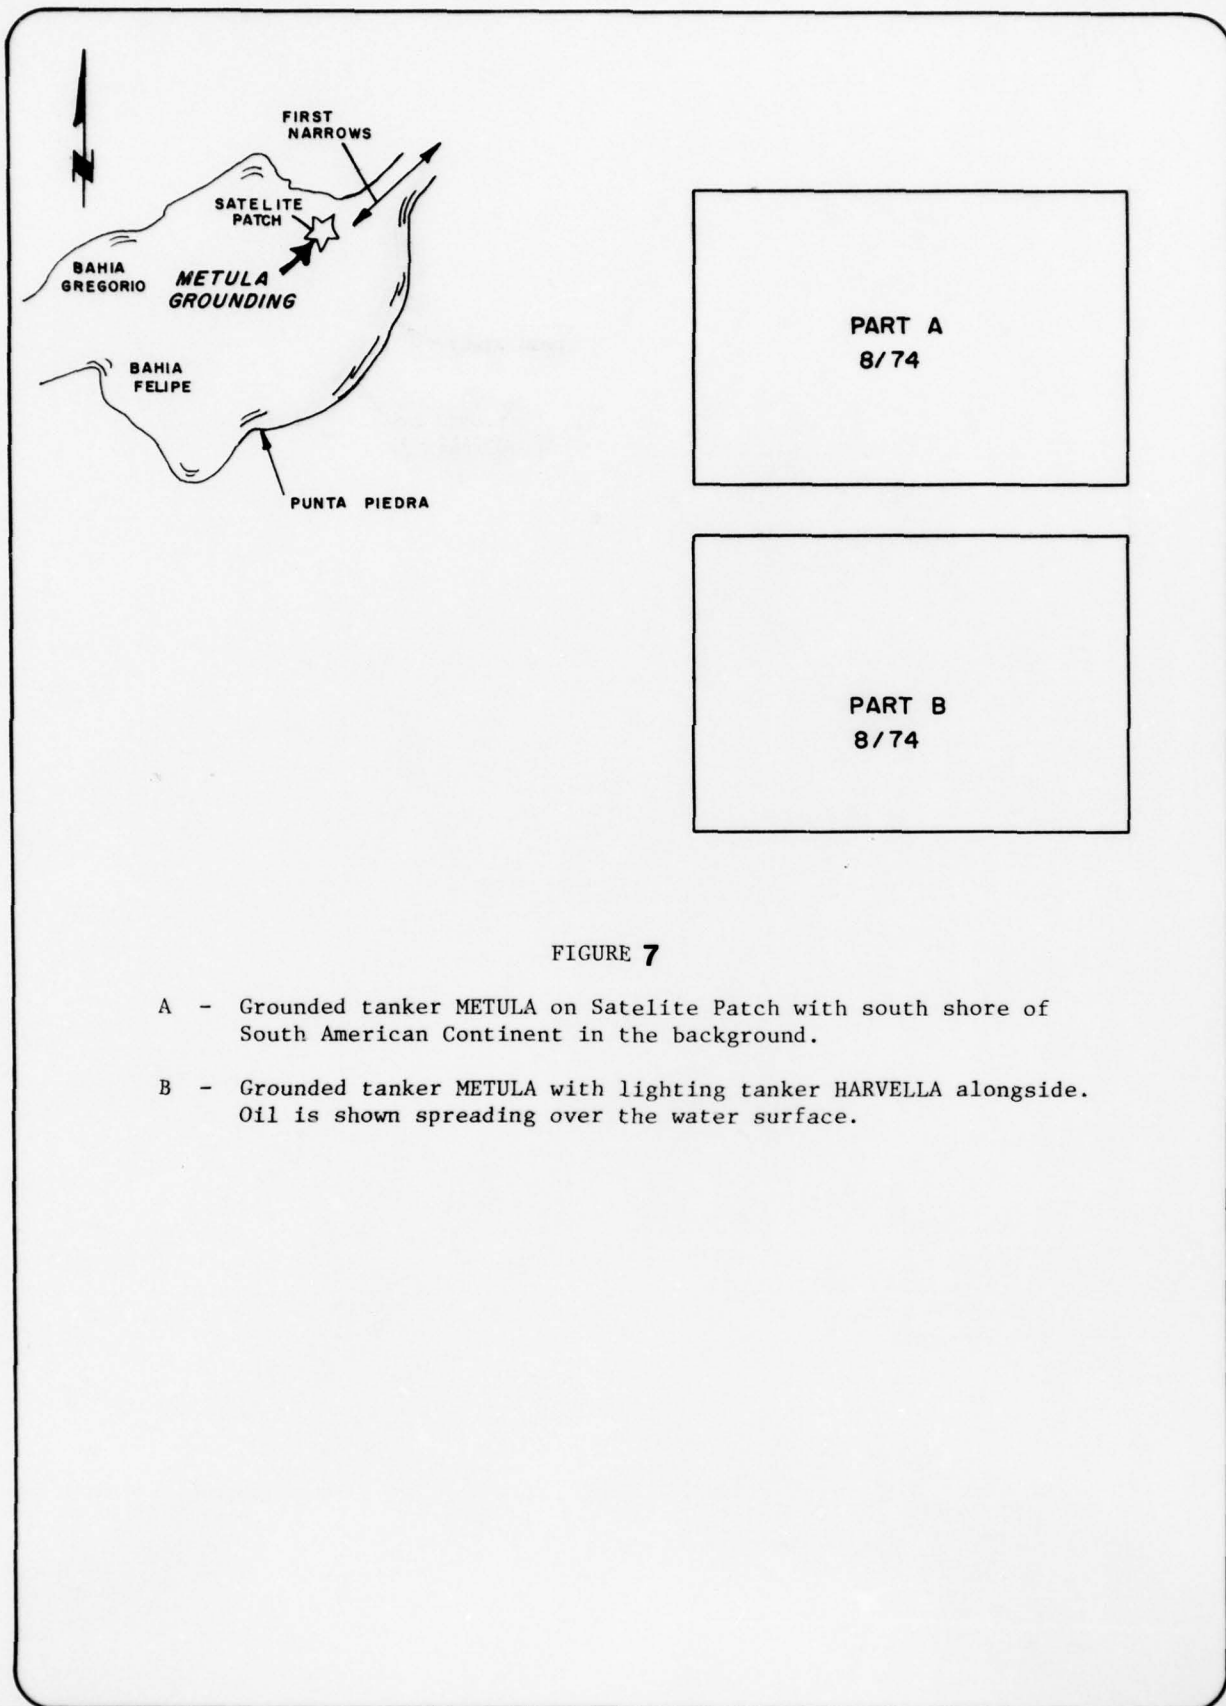
FIGURE 7

- A - Grounded tanker METULA on Satellite Patch with south shore of South American Continent in the background.
- B - Grounded tanker METULA with lighting tanker HARVELLA alongside. Oil is shown spreading over the water surface.

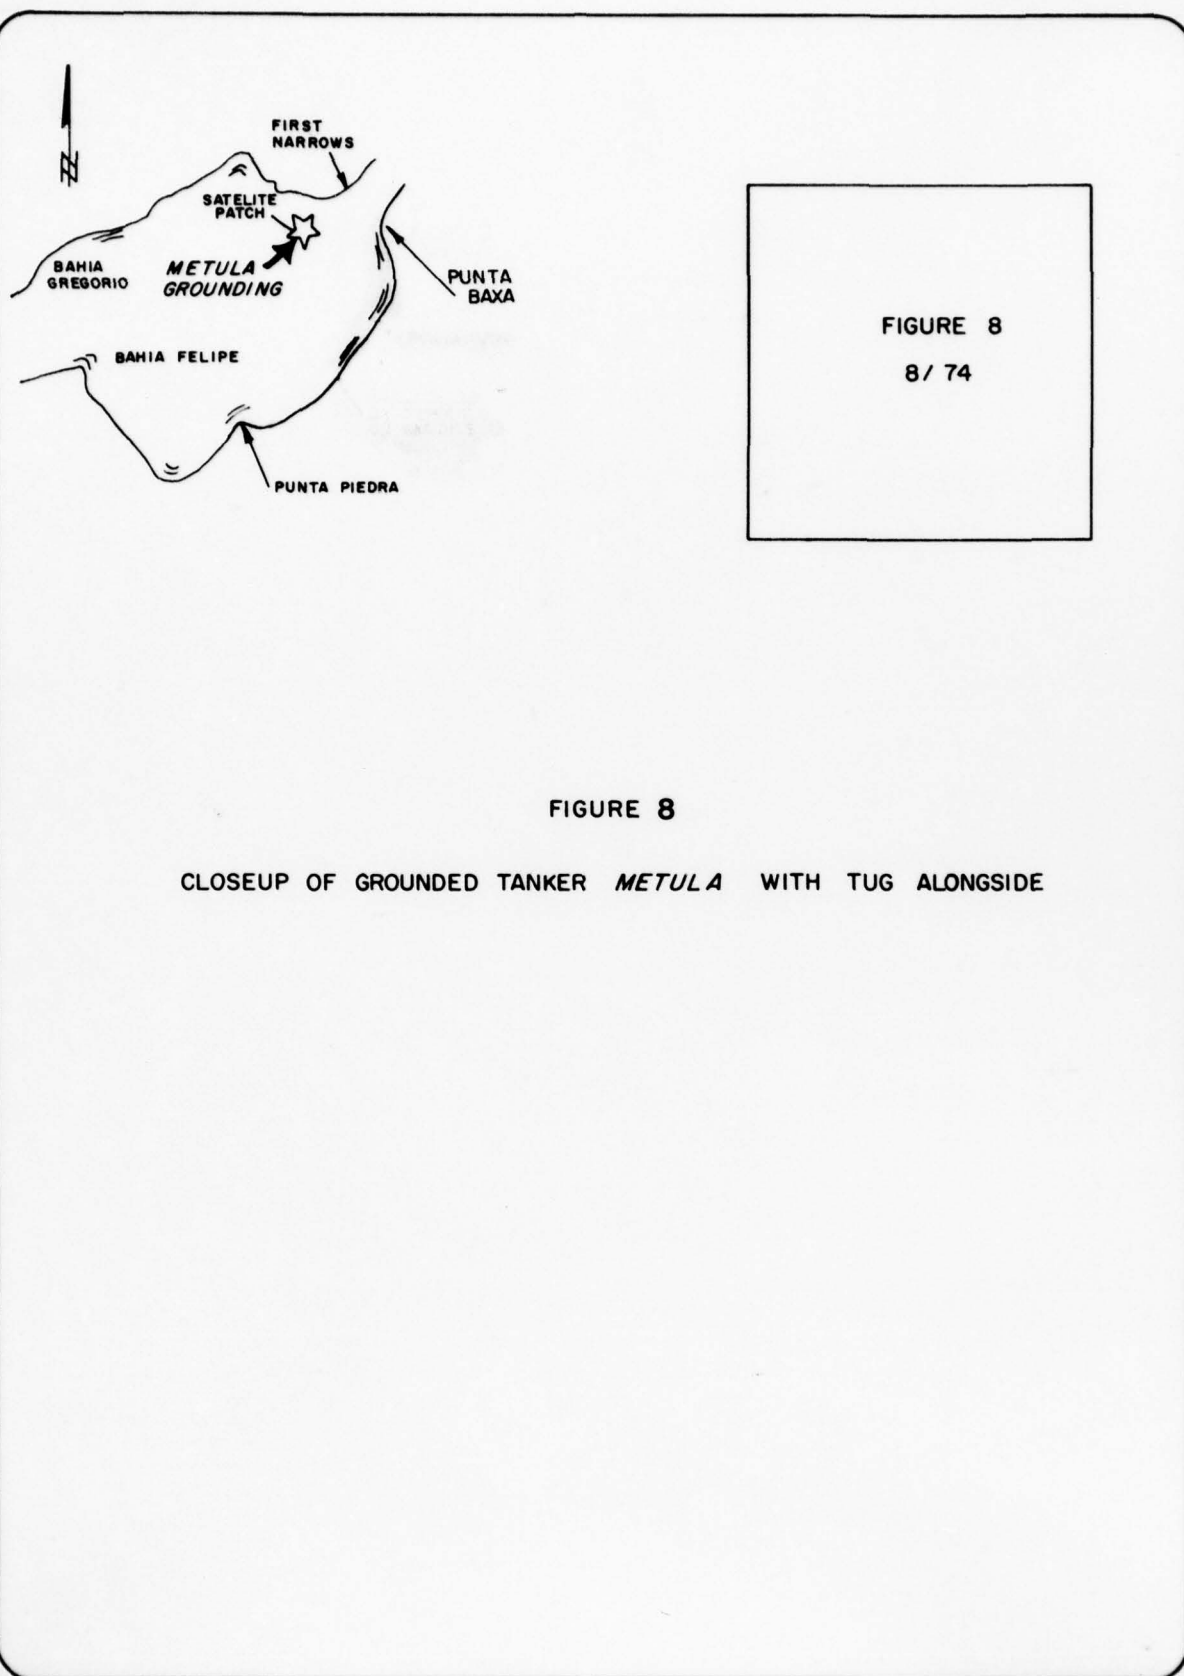
FIGURE 8

CLOSEUP OF GROUNDED TANKER *METULA* WITH TUG ALONGSIDE

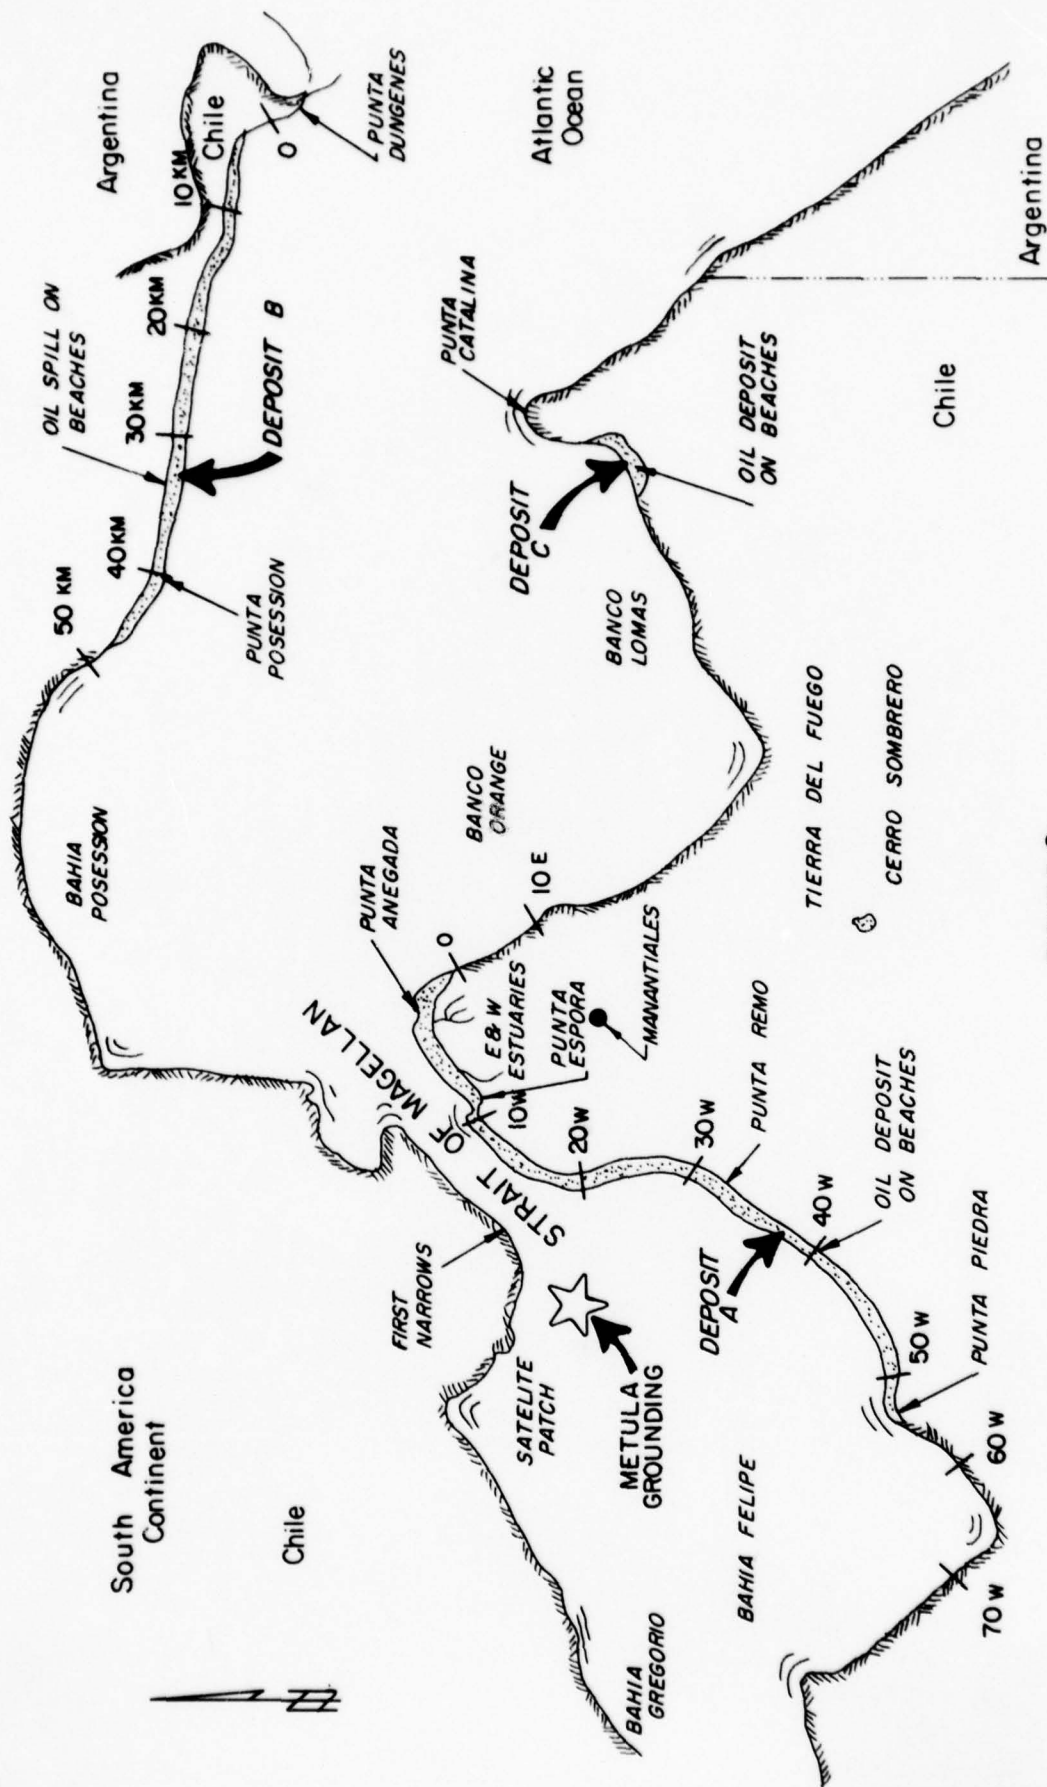
This part of the Strait of Magellan is noted for its exceptional high winds, predominantly from the west, and these winds tended to rapidly drive the oil ashore. Based on an average of 30 knot westerly winds experienced in the area, the oil could expect to travel on the surface at a speed of approximately one knot to impact the shore of Tierra del Fuego within 3 to 4 hours. There it would strand on the shore or be slowly moved along the coastline to the northeast or southwest depending on the wind direction at the time of impact. The winds during August were such that most of the oil that did not volatilize or dissolve into the water column was driven onto the north shore of the Island of Tierra del Fuego as shown as Deposit A in Figure 9. This initial deposition covered between 40 and 50 miles of coastline.

FIGURE 9  
SITE OF GROUNDING AND IMPACTED BEACHES  
( AUGUST- SEPT., 1974 )

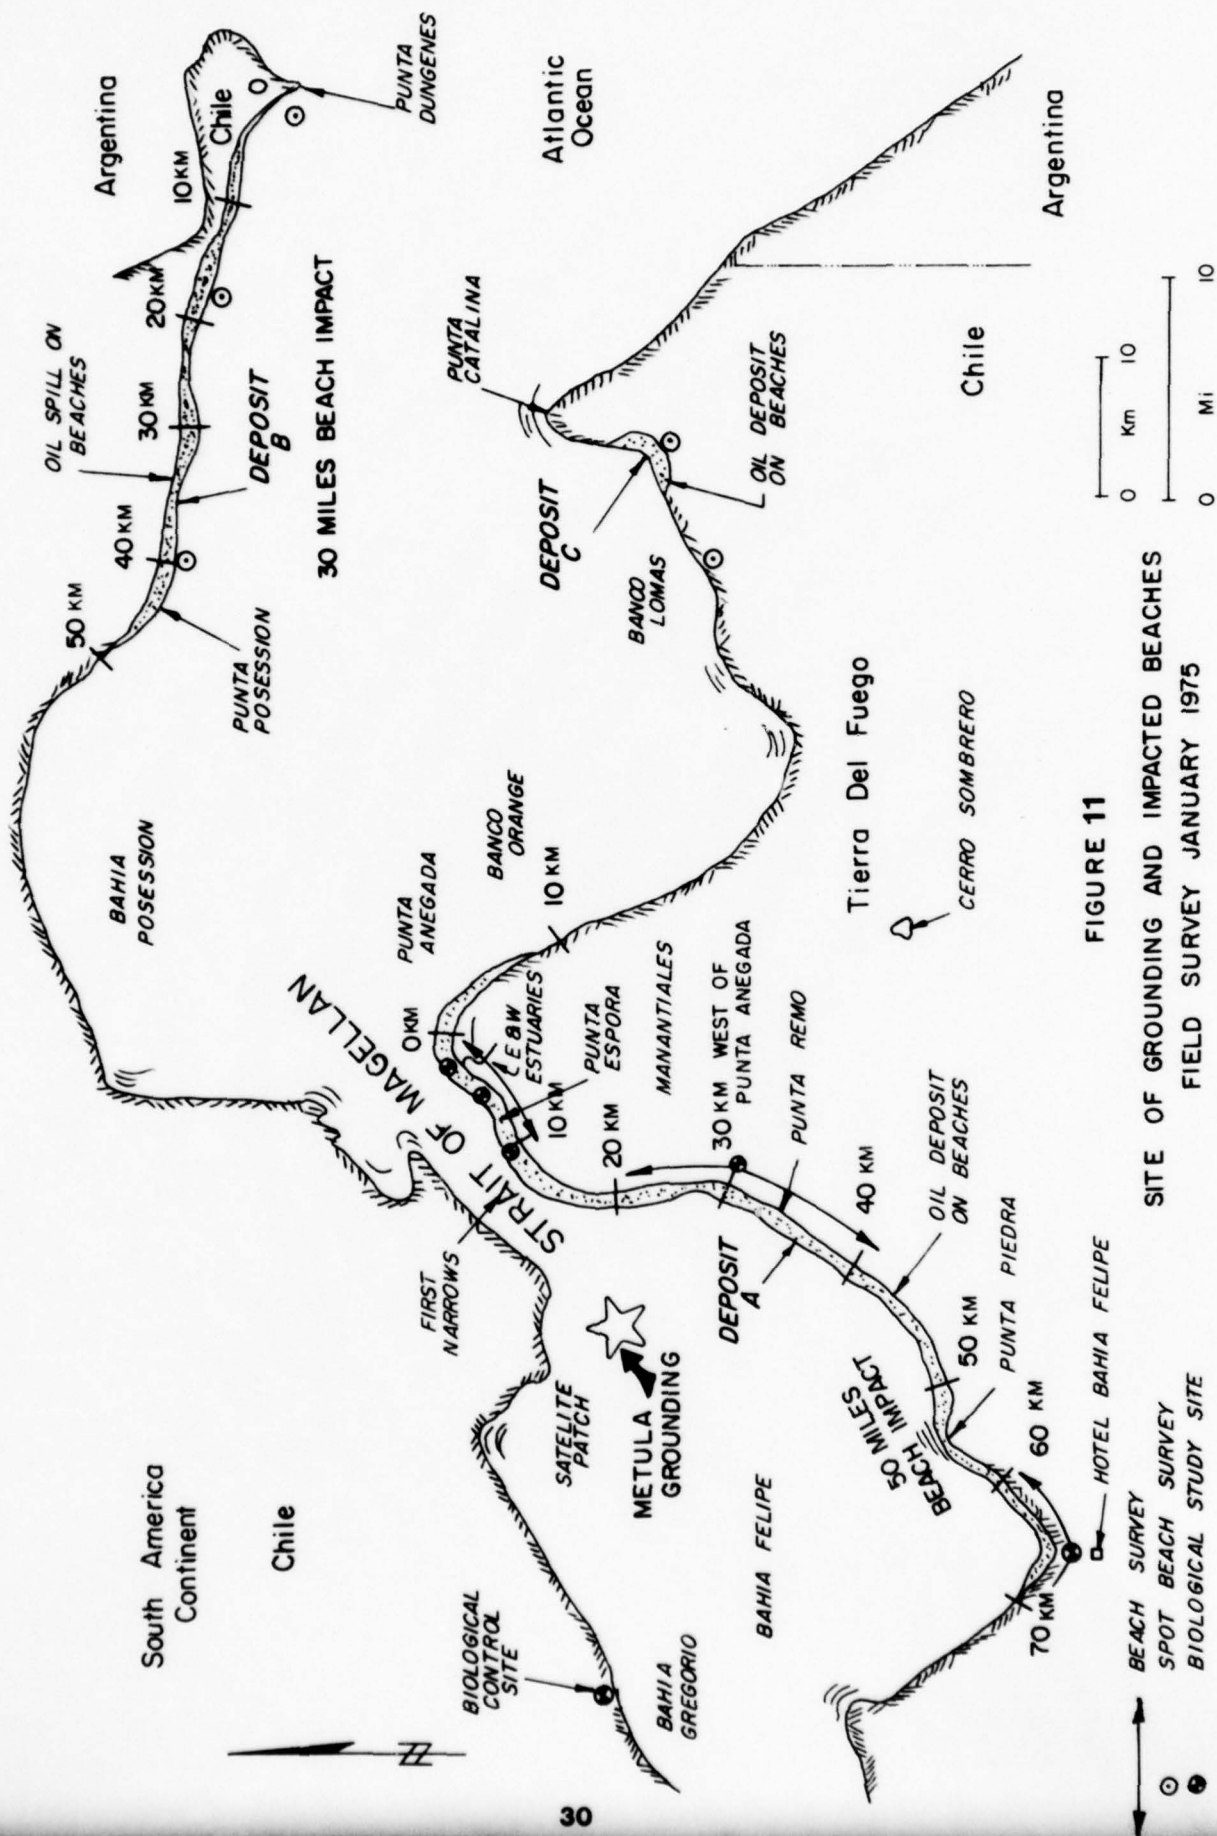
During the following weeks, the mousse continued to spread, be stabilized on the beaches or to be transported to sea. During the following trip in January of 1975, the mousse was observed at more westerly locations on the shore of Bahia Felipe but was generally stabilized in the same areas as observed before. The locations of the deposits in January of 1975 are shown in Figure 11.

**FIGURE 11**  
 SITE OF GROUNDING AND IMPACTED BEACHES  
 FIELD SURVEY JANUARY 1975

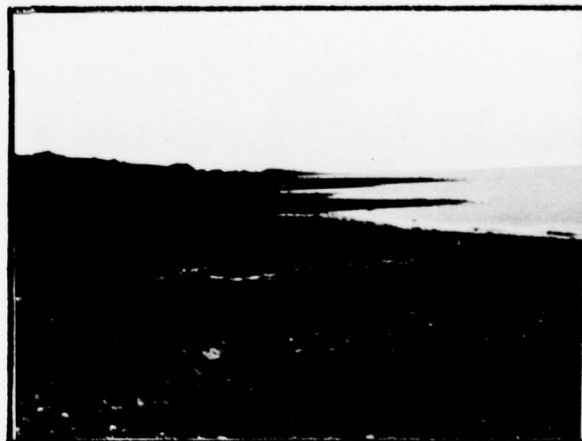
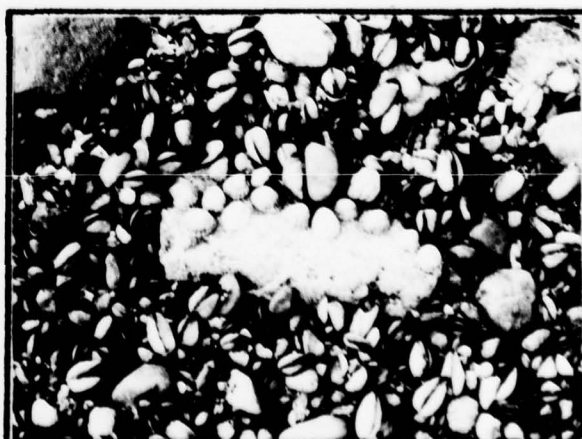
FIGURE 12

Figure 12 Parts A and D show the general area and Parts C and E show closeup of the marine community on, around and under the cobbles. The only oil found in this area has been a tar residue on occasional rocks found at the upper intertidal zone. A handfull of rocks gathered over a half-hour period is shown in Figure 12 Part B.

- A - Typical view of uncontaminated beach showing steep sand beach, stranded detritus and near top of beach and cobble area in lower Intertidal Zone.
- B - Tarred rocks found on Gregorio Beach.
- C - Crustacea living under cobbles in lower Intertidal Zone.
- D - Lower Intertidal community with cobbles, algae and marine life.
- E - Close-up of limpets and mussels in lower Intertidal Zone.

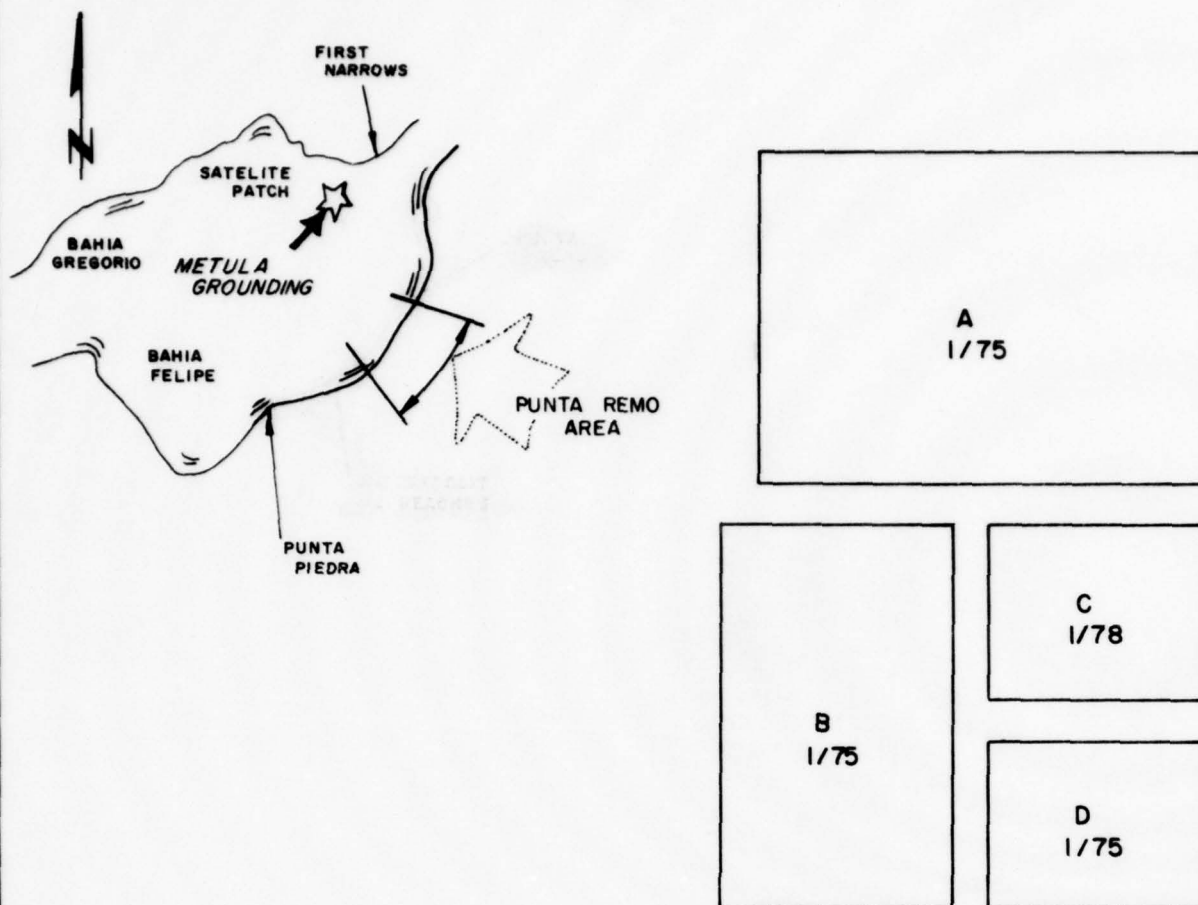
FIGURE 14

On Figure 14 Part A this latter stretch of beach is shown as it appeared in January of 1975. Part B shows an aerial shot of Punta Remo taken in January of 1975. The oiled stretch at the top of the beach and the large cobbled intertidal zone are evident. Part D shows a closeup of the stranded mousse in 1975. Mousse that has been warmed by the sun may be observed oozing down the beach face. Part C of Figure 14 shows the beach top area in 1978. The zone of coverage remains the same. The texture of the oil has changed in that most of the oiled layer now consists of oiled sand rather than mousse. There are, however, some areas where

- A - Oil stranded at the top of the beach in the Punta Remo area.
- B - Aerial photograph showing oiled beach top, sloping beach and wide cobbled zone exposed at low spring tides.
- C - Close-up of oiled beach top near Punta Remo.
- D - Oil leaching from beach top deposits under the heating effect of the summer sun.

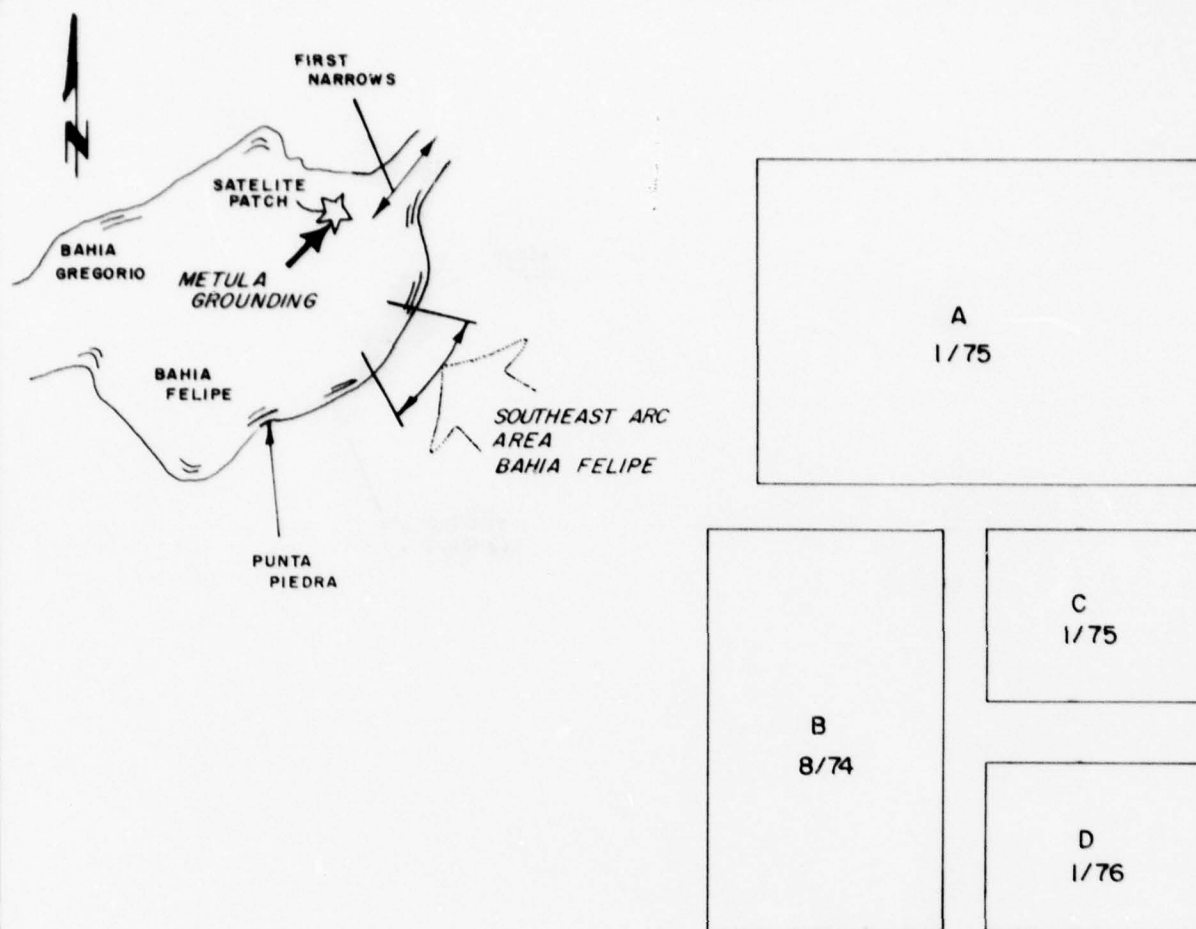
FIGURE 15

The wave on the beach in this zone had brown oil stained edges from resuspended oil which would leave random wavy lines in the lower zones of the beach as the tide would come in and go out. Figure 15 Part A shows a typical view of this stretch of beach in January of 1975. Figure 15 Part D shows a group of tarballs found at the base of the beach slope in January 1976.

- A - View of oiled beach top in maximum impact area on Bahia Felipe, exposed oil is to the left of the picture and covered oil under the sand on the right.
- B - Aerial photo of southeast arc area of Bahia Felipe during the time of the spill.
- C - Aerial photo of similar area five months after the start of the spill.
- D - Tar balls found at the base of the beach slope.

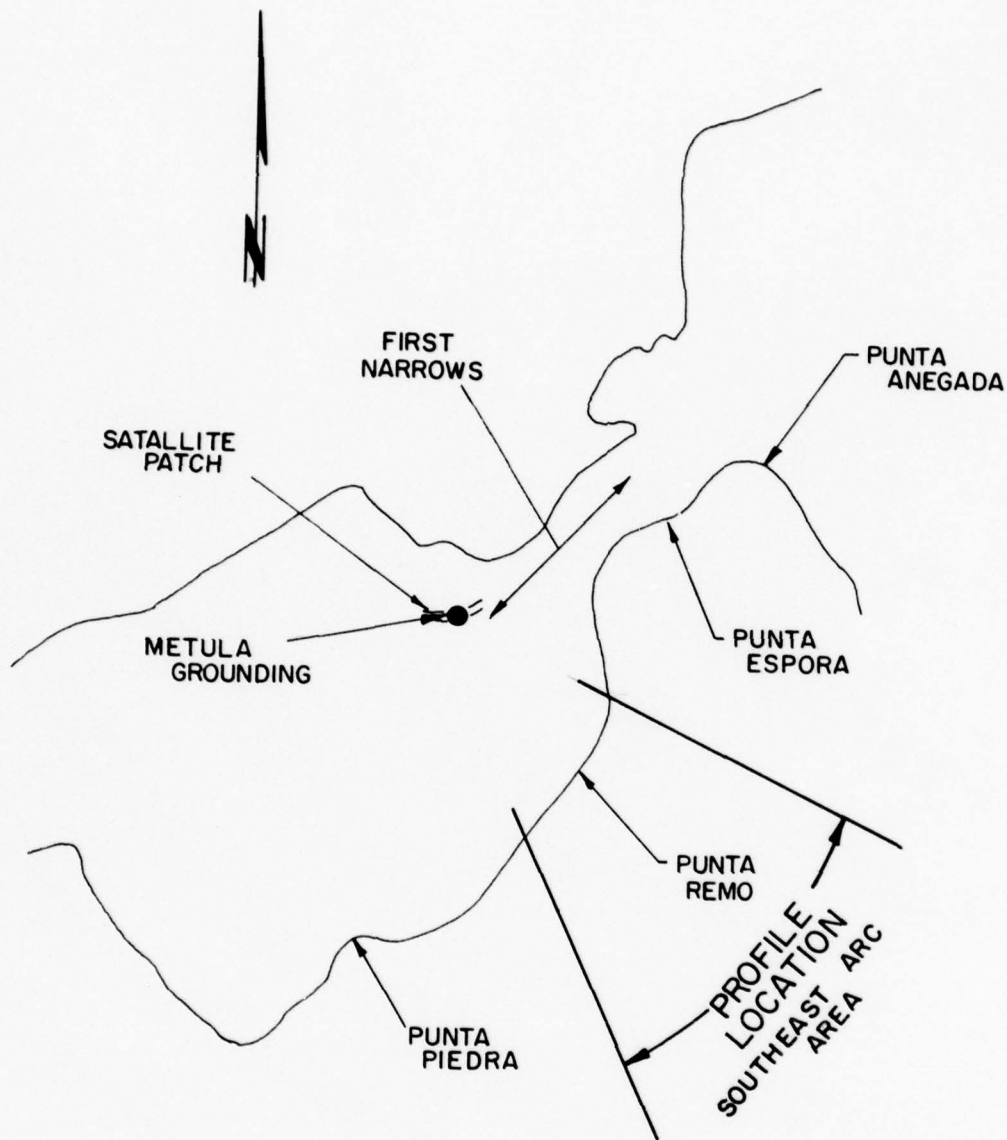
Figure 17 shows a profile across a typical beach in this area in 1976. At this location oil and mousse was still in evidence over a zone 30 meters (100 ft) wide.

FIGURE 17  
BEACH PROFILE SOUTHEAST ARC AREA BAHIA FELIPE

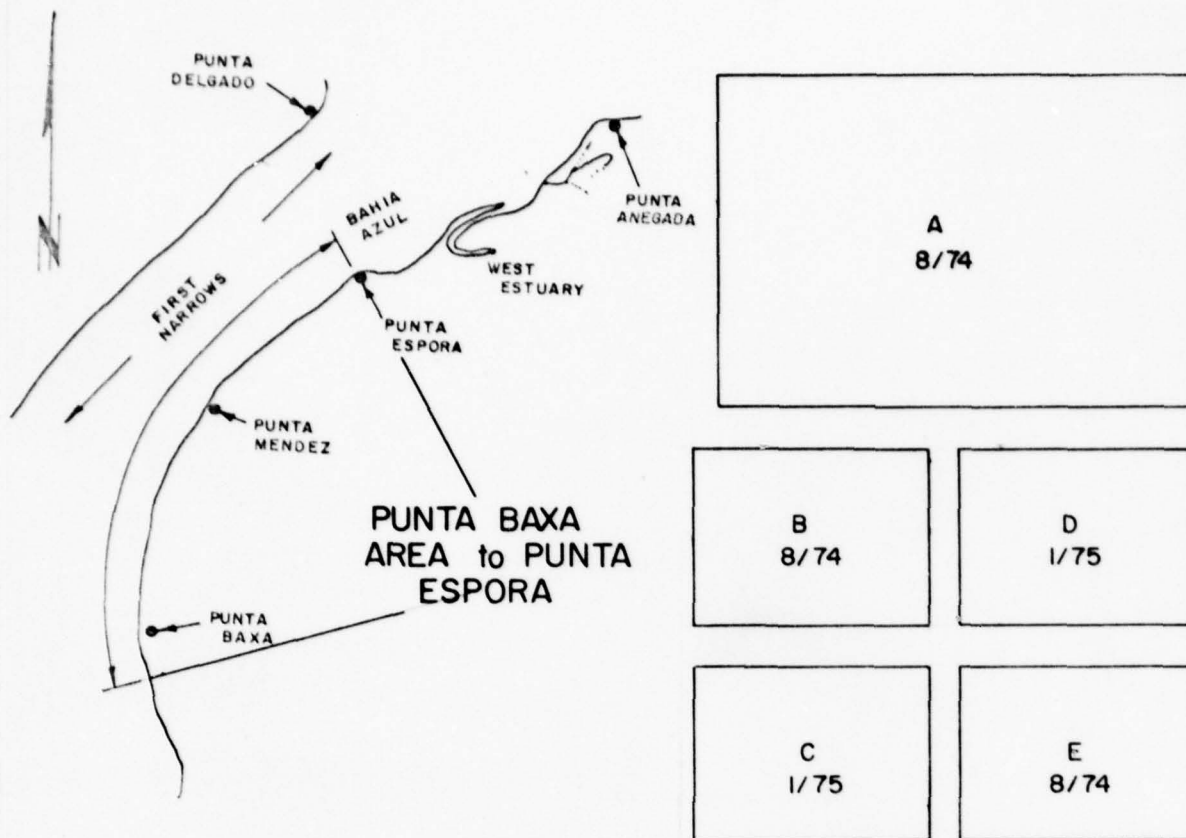
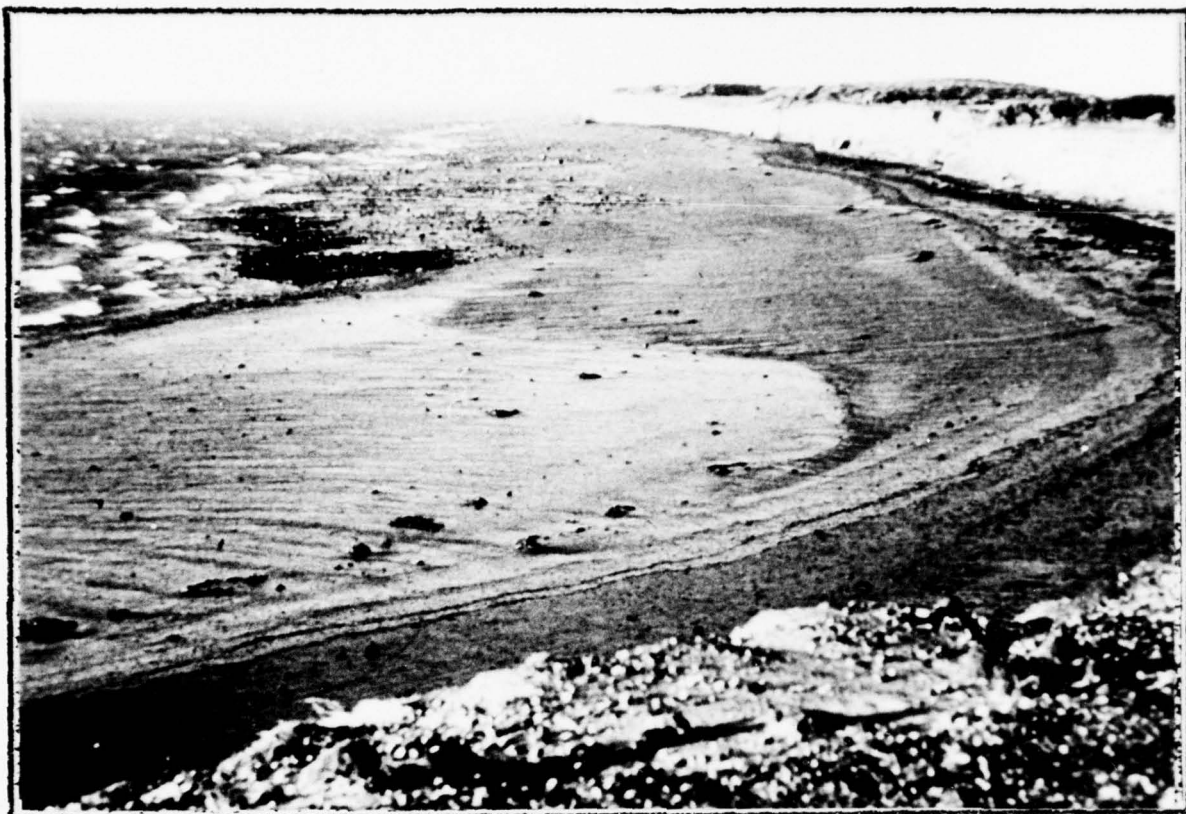
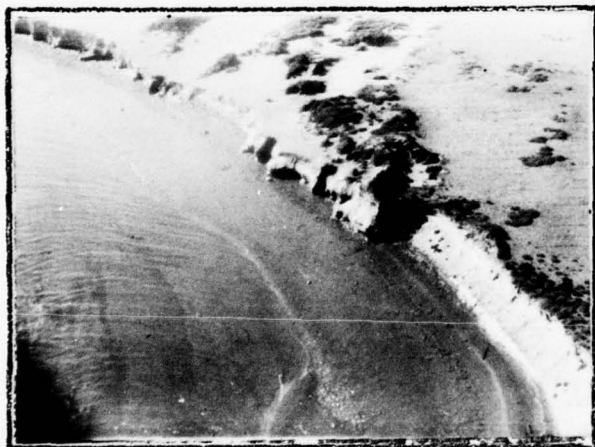
FIGURE 18

The cliff zone which stretches south from Punta Baxa at the entrance to the Narrows to where it intersects the Southeastern Arc was also heavily oiled at the time of the spill. Figure 18 Parts B and E show aerial photographs of this zone at the time of the spill and Figure 18 Part A shows a view from a cliff top of the same general area. This area differs from the Southeast Arc in that cliffs are found at the top of the beach. This resulted in the oil being retained at a zone where future wave action could work on the deposits. At the time of the spill it was noted that the action of the surf against the base of the cliffs had in some places thrown oil on the top of cliffs 8 to 10 meters high. The deposits on the beaches at the time of the spill generally ranged from 30 to 100 meters wide (98 to 328 ft) depending on the beach slope.

- A - Oiled beach zone in Punta Baxa area during the spill period.
- B - Another oiled beach zone during the spill period.
- C - Same beach area observed five months later.
- D - Same beach area with dead horse observed five months later.
- E - Aerial photograph of Punta Baxa beach area.

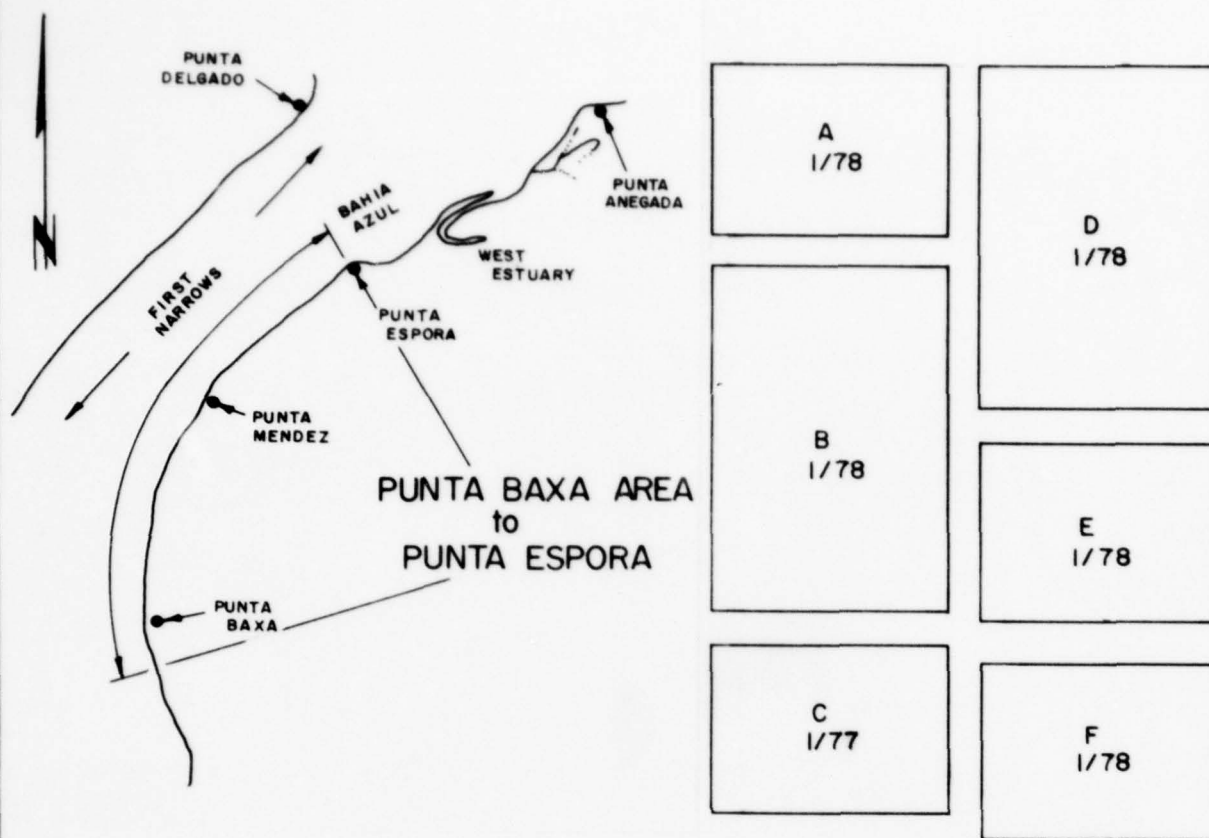
FIGURE 19

Unique in this area are the large number of tar balls and tar slabs found at the base of the beach slope. These are shown in Figure 19 Parts A and B. These may have resulted from the erosion of the oiled zones at the beach top. Since the beach in this area was building at the time the question is raised as to whether there is a large amount of buried oil under the bottom of the beach slope.

- A - Tar slabs at bottom of beach face in Punta Baxa area.
- B - Tar balls at bottom of beach face in Punta Baxa area.
- C - Tarred rock face on south shore of First Narrows.
- D - Eroded oil layers at foot of cliffs in Punta Baxa area.
- E - Heavy mussel population on large rock in cobble area near Punta Baxa.
- F - Oil on top of small cave at top of beach near Punta Baxa.

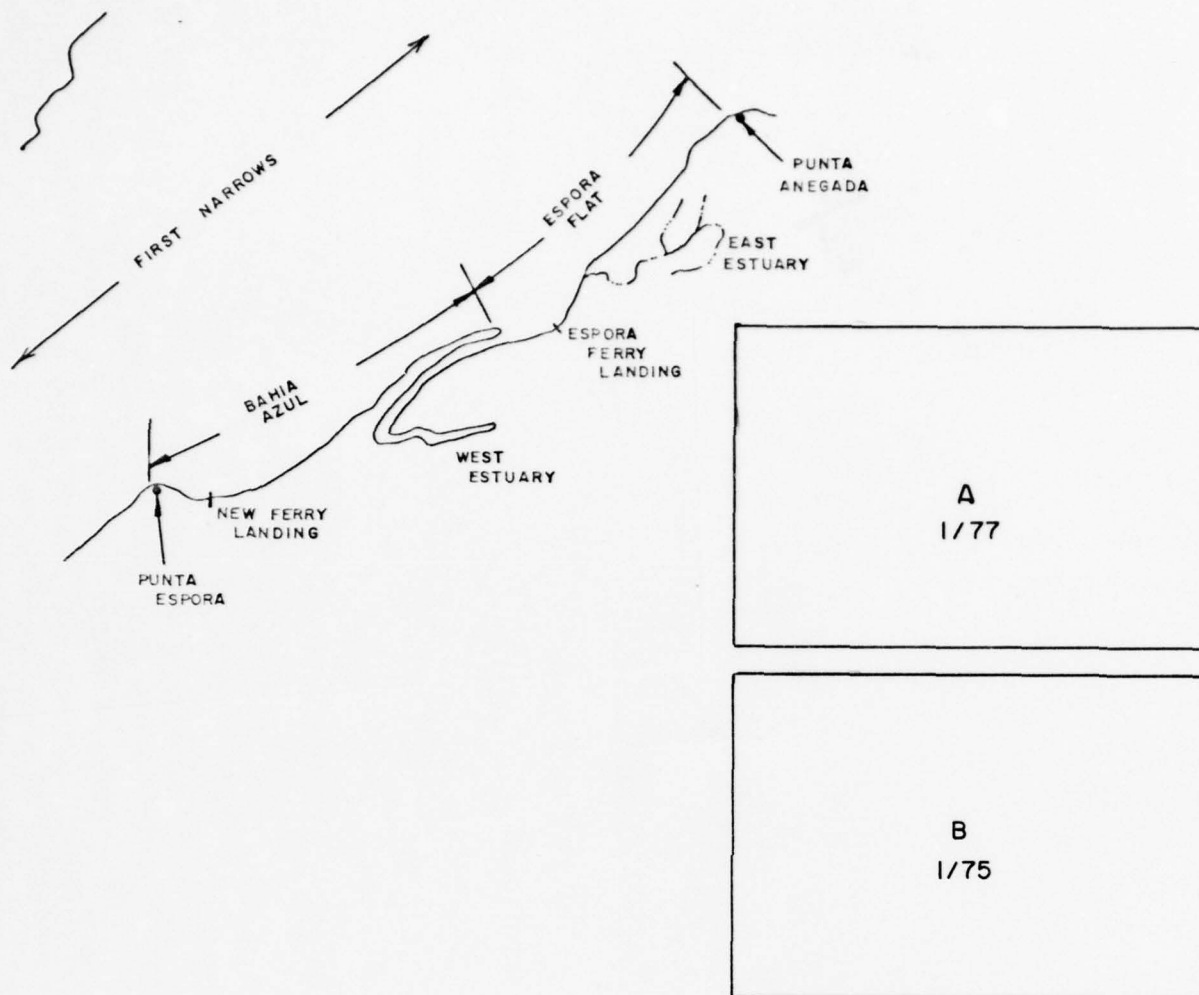
FIGURE 21

The Bahia Azul Beach was not observed at the time of the spill but the construction of the new ferry landing and access road in late 1974 made observation possible in January of 1975. Figure 21 Part B shows the Azul Beach at the new ferry landing. The clean undersides of rocks disturbed by the construction contrasted drastically with the oiled beach face in the foreground and background.

- A - View of Bahia Azul Beach showing new road and ferry loading. Punta Espora is in the lower lefthand corner.
- B - View of oiled beach face on Bahia Azul. New construction has turned over rocks in piling area in contrast to oiled rocks in foreground and background.

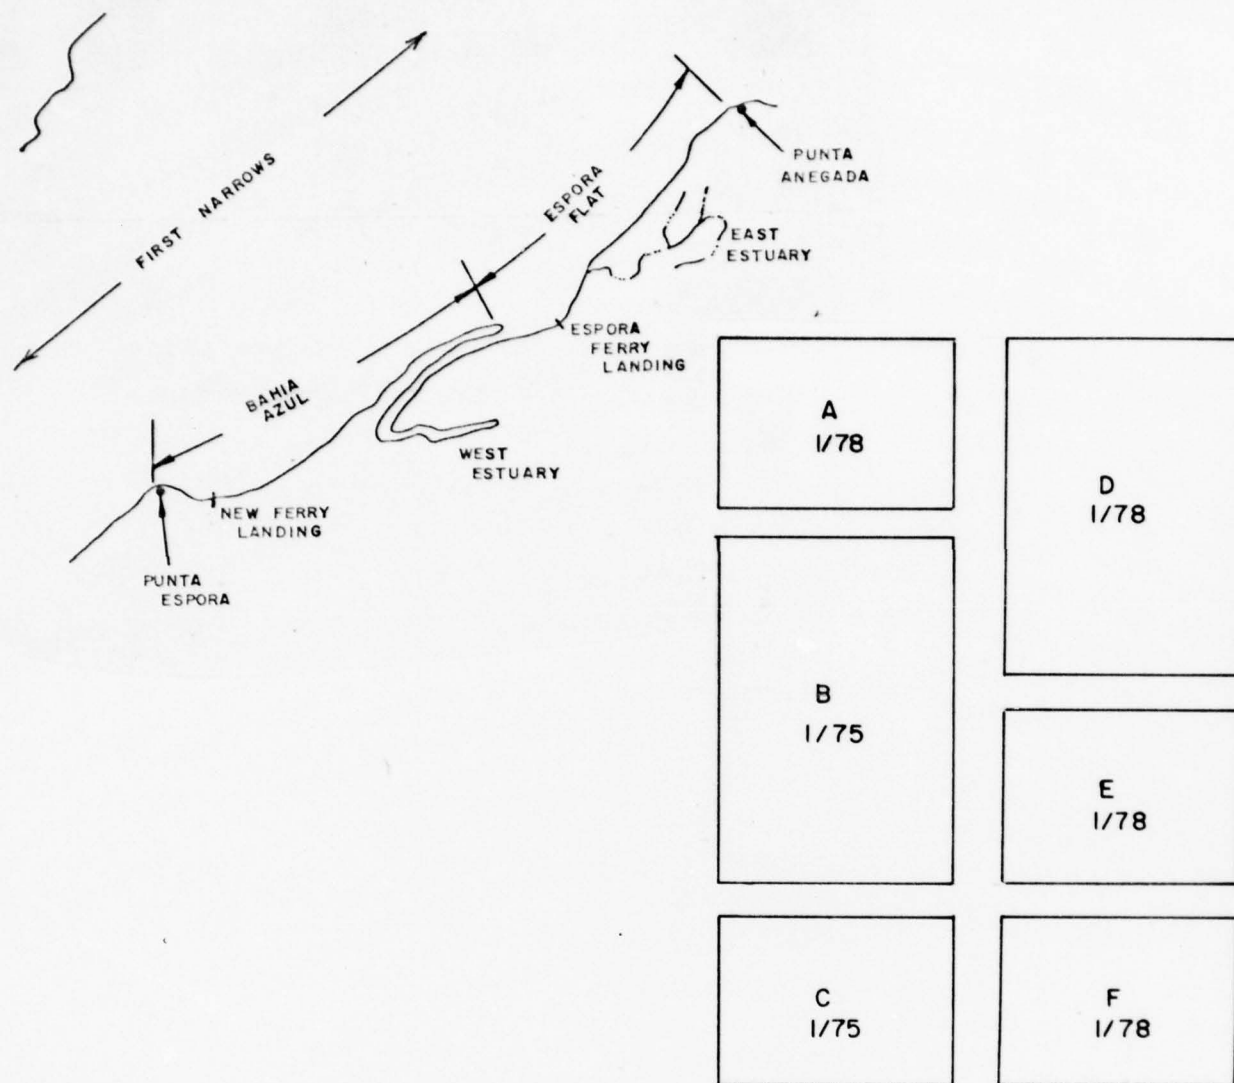
FIGURE 22

The entire beach zone in this area is heavily oiled. Figure 22 Parts A through F shows views of this beach in 1975 and 1978. Figure 23 shows a beach profile made in 1975. Almost an identical profile was observed in 1978 except for the relative absence of oil in the sandy zone between the oiled layer at the top (Figure 22 Parts C and F) and the paved cobble area shown in Figure 22 Parts A, B, D and E.

- A - Paved beach to south of New Ferry landing on Bahia Azul.
- B - Closeup of oiled pavement on Bahia Azul Beach.
- C - Oiled shell and flat stone beach top deposit in January 1975.
- D - Series of sampling pits perpendicular to the beach on Bahia Azul shore.
- E - Closeup of oiled pavement.
- F - Oiled shell and flat stone beach top deposit in January of 1978.

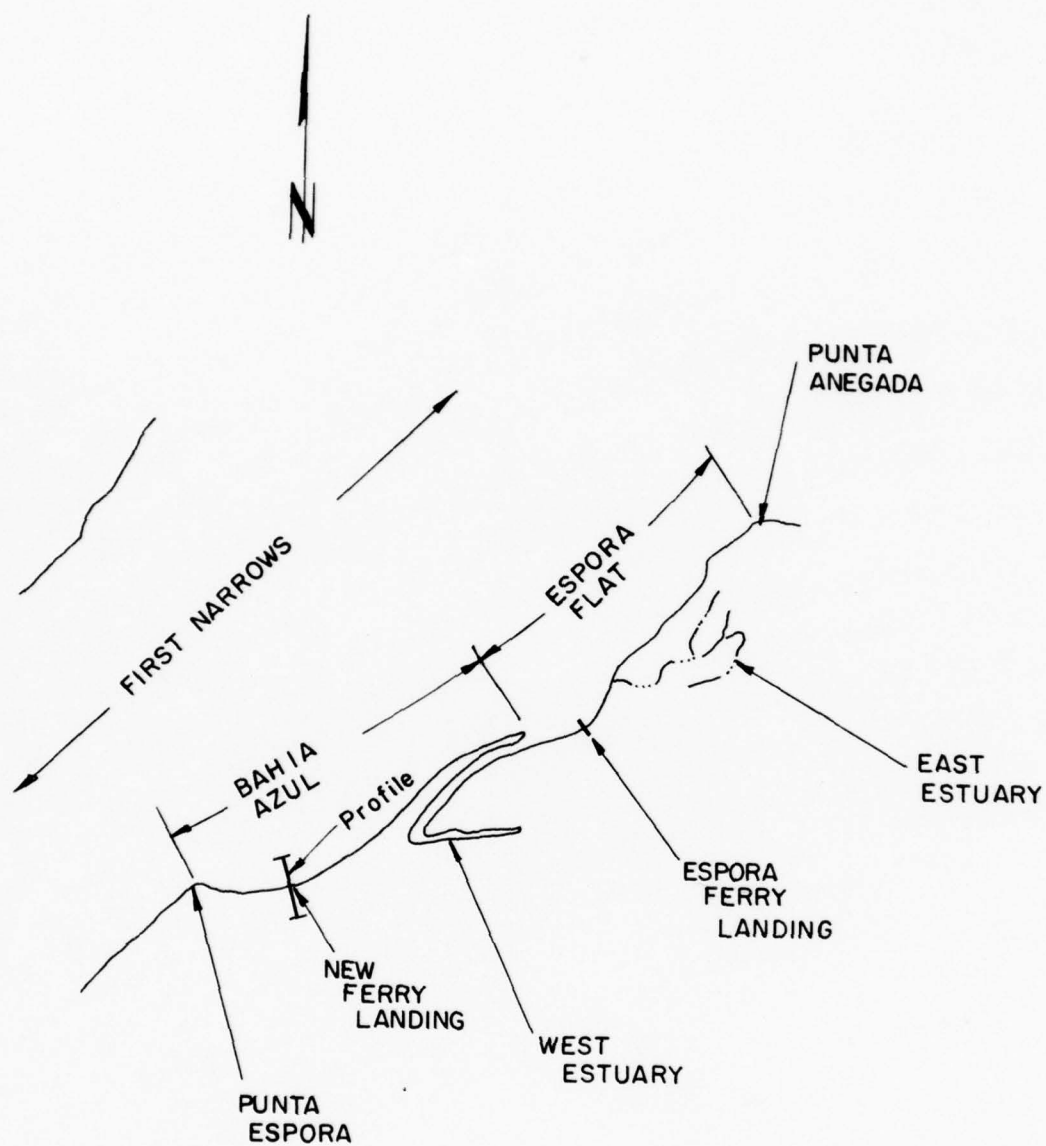
FIGURE 23

BEACH PROFILE BAHIA AZUL BEACH FACE

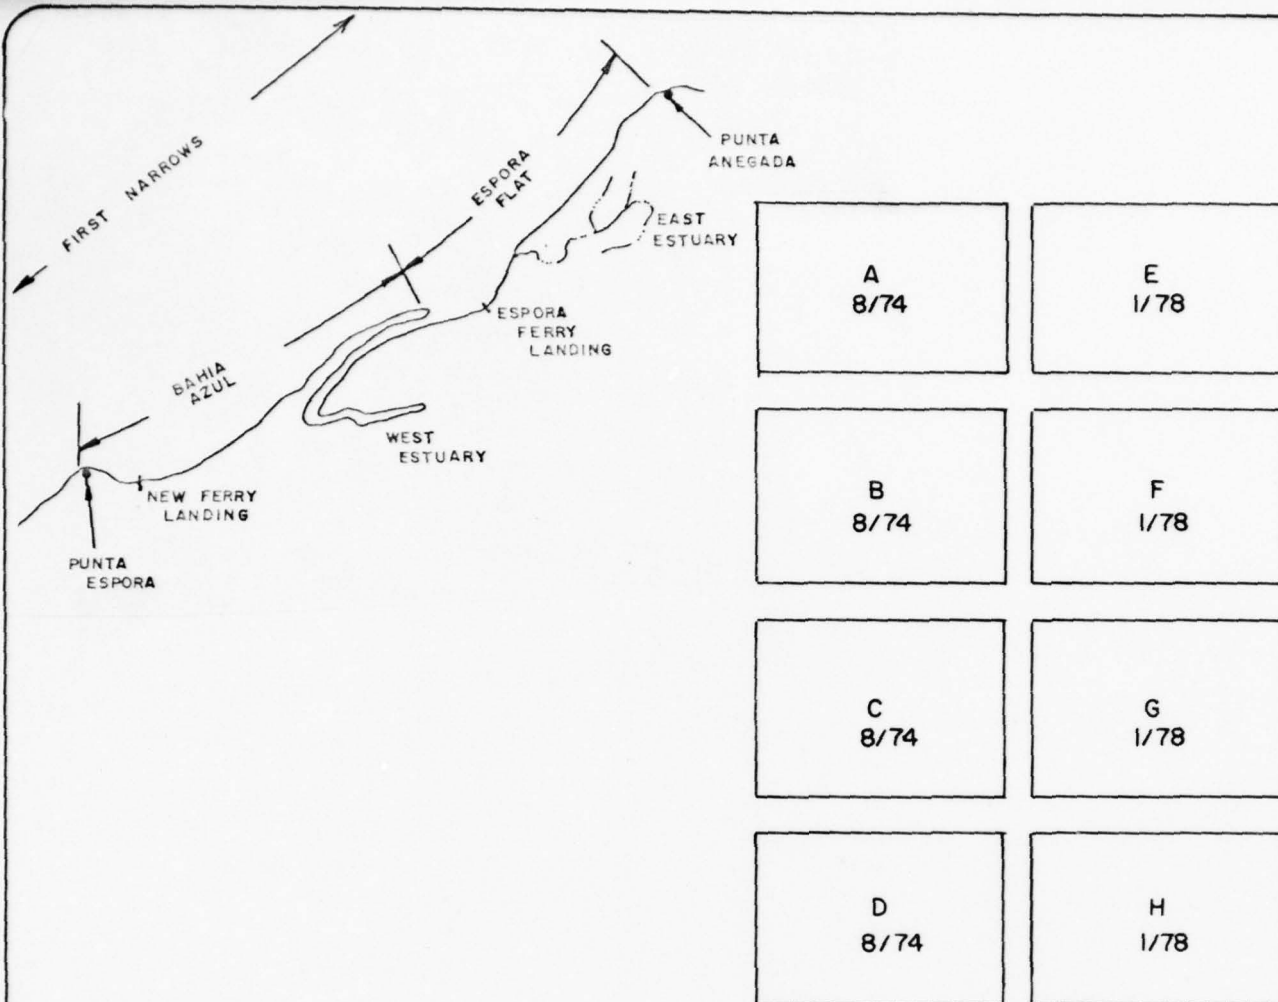
FIGURE 24

- A - Espora beach top at time of the spill.
- B - Old Ferry Landing at Puerto Espora at low tide during the spill.
- C - Stranded oil draining down beach face during time of the spill.
- D - Ferry Unloading on oiled Espora beach.
- E - Weathered oiled beach top looking west at Espora in January 1978.
- F - Weathered oiled beach top looking east at Espora in January 1978.
- G - Close-up of weathered sediments at top of Espora beach.
- H
